## Performance of Driven Piles in Gravelly Sands With Cobbles

## PERFORMANCE OF DRIVEN PILES IN GRAVELLY SANDS WITH COBBLES

This case study presents observations of pile construction for a bridge retrofit in the city of Irwindale, California. This paper will provide an overview of the retrofit design, subsurface conditions, challenges during construction, the alternative method of installation, and concluding remarks on pile construction.

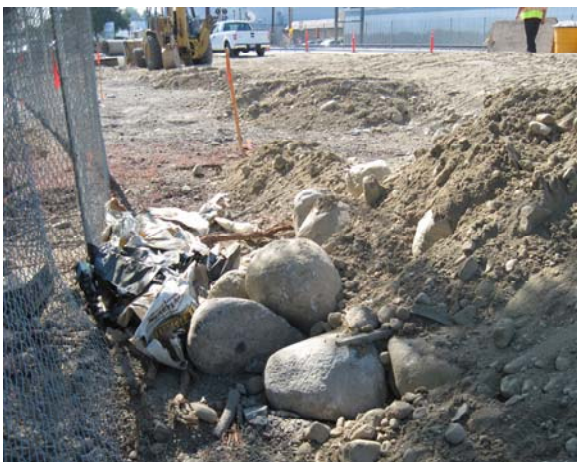
Initial excavations and shoring installation for the pile cap uncovered large cobbles and boulders up to 2 feet in diameter. As construction progressed, more subsurface information became available through visual inspection of excavated materials. It became clear that an abundance of oversize materials were present in the subsurface (Figure 1).

*Fig. 1. Cobbles and boulders encountered during initial excavation and shoring installation.*

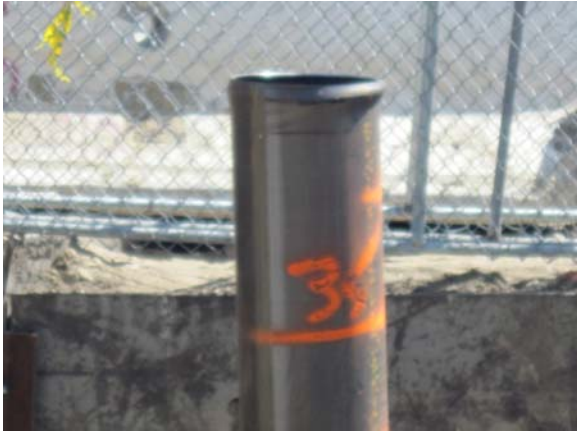
Significant structural damage of the steel was observed at refusal. A mushrooming effect was observed at the pile top (Figure 2). Significant buckling of the steel pipe pile was observed at the pile tip, creating an “accordion” pattern along the pile (Figure 3).

*Fig. 2. Mushrooming effect at the pile top.*

The use of a heavy diesel hammer was unsuccessful in driving close-ended steel pipe piles to their target elevation. The presence of gravels, cobbles and boulders created heavy driving resistances that could not be sustained by the quarter-inch thick steel section. The pile collapsed in between the rigid steel plate bottom and the hammer apparatus attached at the top, creating an accordion-like pattern along the steel pile. The fragility of the quarter-inch thick steel section became more apparent when the plate bottoms were removed and the pile was driven as an open-ended steel pipe pile. Piles driven in this manner encountered refusal quickly and pile ends failed in shear as a result of heavy driving resistances. In both cases, pre-drilling 14-inch-diameter holes did not facilitate pile driving due to severe caving of the soils. Both close-end and open-ended steel pipe piles designed per Caltrans Standard Plan B2-5 Alternative V, did not perform well when driven into gravelly sands with cobbles. A pile drive-ability study could have provided additional insight as to whether the steel pipe pile was capable of withstanding the driving stresses of a heavy diesel hammer.

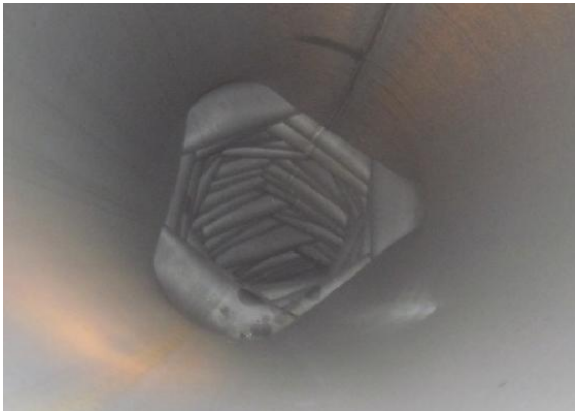
*Fig. 3. Buckling failure of closed-end steel pipe pile viewed from inside the pile.*

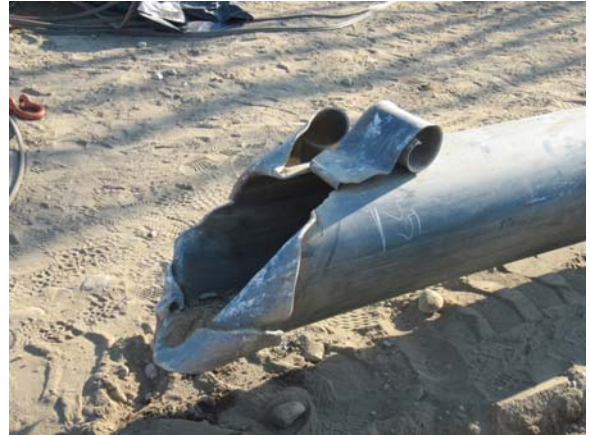
Structural damage of the steel for open-ended piles was also observed at refusal. Piles were extracted and examined upon refusal. The same mushrooming effect was observed at the

pile top as with closed-bottoms. Significant shearing of the steel was observed at the pile tips (Figures 4 and 5).

*Fig. 4. Shearing of open-ended steel pipe pile tip after extraction.*

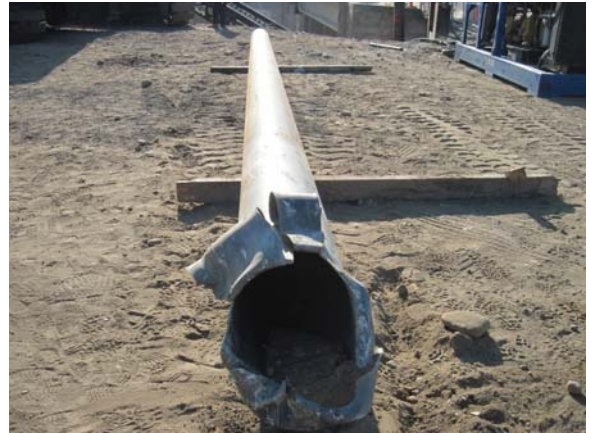
*Fig. 5. Shearing of open-ended steel pipe pile tip after extraction.*

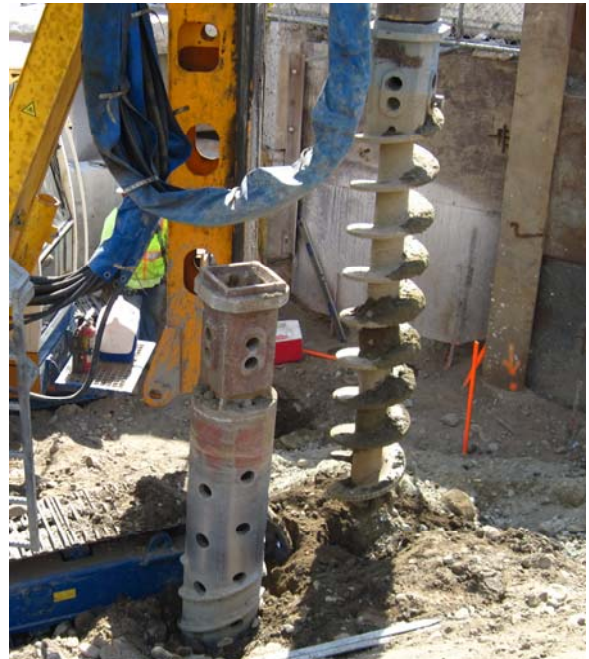
Drilling was performed using a production scale Bauer BG 24 track-mounted rotary drill rig, with a combination of solid flight auger and core barrel attachments (Figure 6). Difficult drilling conditions had been identified in the geotechnical report and were anticipated for the pre-drilling of 20 inch diameter holes. Nonetheless, the alternative method of installation was successful; however, drilling was slow and the contractor was only able to install 1-2 piles per day. As expected, it was difficult to control the caving sands and oversized materials were frequently falling into the open excavations that were difficult to remove.

*Fig. 6. Core barrel and solid flight auger.*

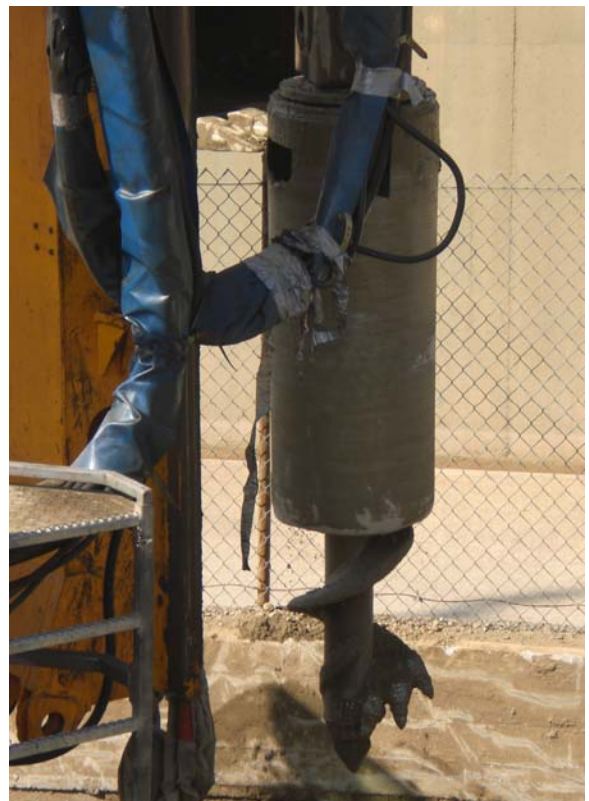
At this time, the contractor elected to fabricate a specialized drill bit to complete the job. The bit was comprised of both a flight auger and a barrel (Figure 7). The tip of the auger was able to advance slightly ahead of the barrel, allowing the barrel to act as a temporary casing holding oversized material in place during drilling. This specialty bit allowed the contractor to slightly increase production of drilled holes;

*Fig. 7. Specialty drill bit to control caving*

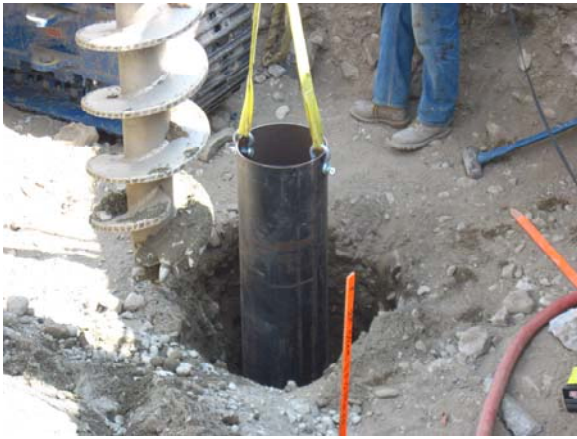
*Fig. 8. Steel pipe pile being placed into pre-drilled 20-inch-diameter hole.*

All twenty-seven piles were installed successfully using this method (Figure 8). Some piles were unable to be removed and were filled with concrete and abandoned in place.

After a collaborative meeting with the contractor and construction inspectors, it was agreed to pre-drill larger diameter (20 inch) holes to tip elevation and place steel piles in them without driving. The annular space between the steel pipe pile and the cored hole was to be pressure-grouted and the center of the steel pipe filled per Caltrans Standard Plan B2-5 Alternative V (Caltrans, 2006). From a geotechnical standpoint, the alternative method of installation essentially created CIDH piles using the steel pipe piles as reinforcement.
